Pavement Condition Study for Gray, Maine

PREPARED FOR:
Town of Gray
24 Main Street
Gray, ME 04039

February 2022

SUBMITTED BY:
Gorrill Palmer
707 Sable Oaks Drive
Suite 30
So. Portland, ME 04106
207.772.2515

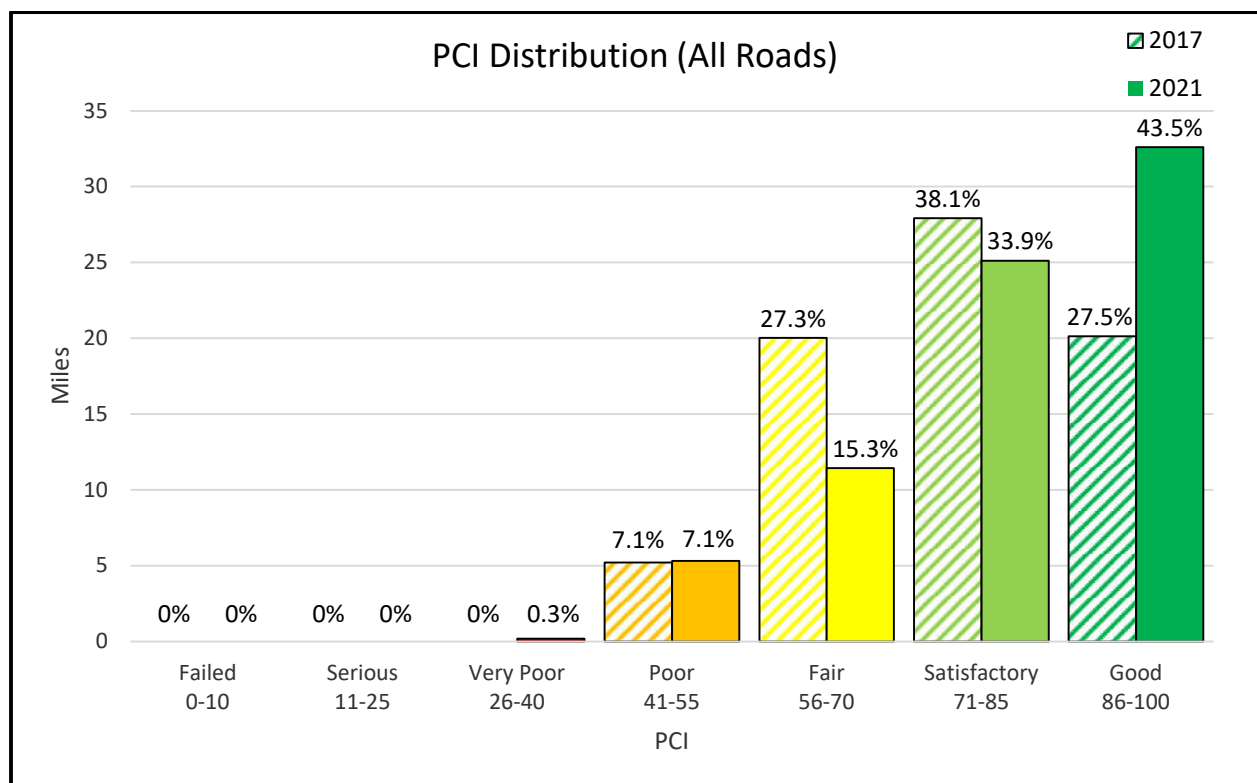
The Town of Gray retained Gorrill Palmer (GP) to complete a pavement condition study and report to guide future maintenance and rehabilitation of pavement. Gorrill Palmer evaluated 74.7 miles of roads, including 59.5 miles of local/urban compact roads and 15.2 miles of state roads during July 2021 to obtain Pavement Condition Index (PCI) values. The 2021 PCI for the entire road network in the Town is 79.20 (local/urban compact and state roads combined), which equates to a “Satisfactory” condition. The 2021 PCI for local/urban compact roads only is 80.17, which equates to a “Satisfactory” condition. The 2021 PCI for state roads is 75.68, which also equates to a “Satisfactory” condition. Overall, the Town appears to be doing a good job in maintaining their paved infrastructure. Figure I below shows the miles of road sections in each condition for combined state and local/urban compact roads. Approximately 92.7% of all road miles (state and local/urban compact) are in “Fair” or better condition. The percentages above each bar represent the percentage of road miles in those conditions.

Figure I - Miles in each condition (state and local/urban compact roads)

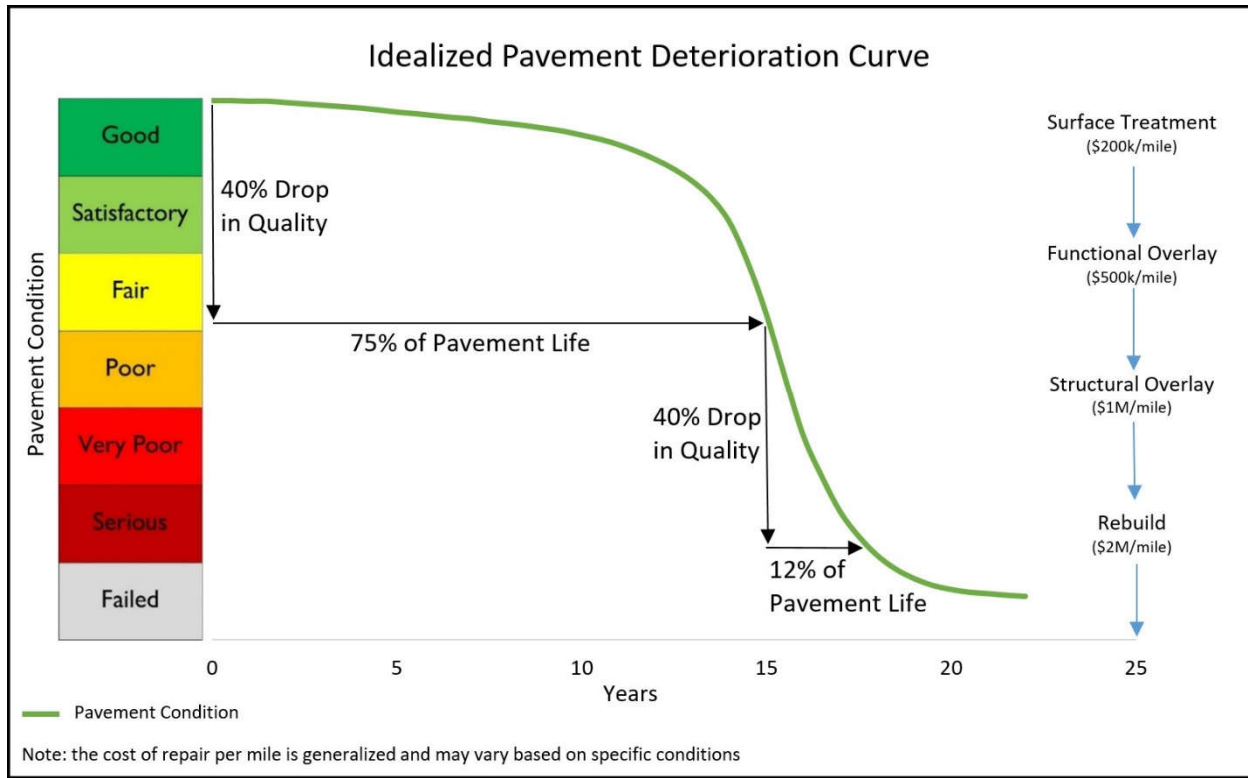
Figure 3 illustrates that the ideal timing to complete preventive maintenance is before the pavement condition reaches a point where pavement rehabilitation is required. It is significantly less expensive to complete a pavement overlay on a roadway than to reconstruct a roadway. It is important to complete preventive maintenance to maintain the condition of the roadways so that they do not reach a point where reconstruction is the only solution. This “keep good roads good” concept is the same philosophy Paver™ uses when creating Maintenance & Repair (M&R) Work Plans.

Figure 3 – Pavement Deterioration Curve

Note: The cost per mile estimates are approximate and can vary greatly depending on many variables such as distress type, distress severity, distress frequency, etc.

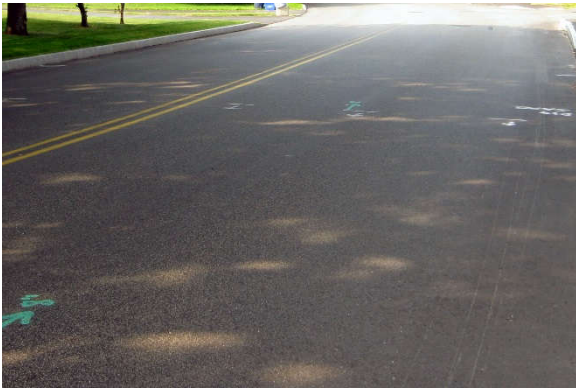
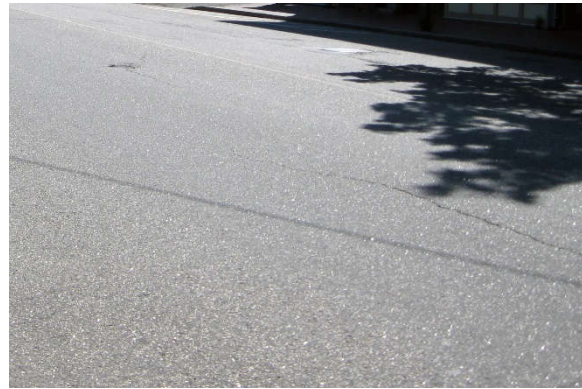
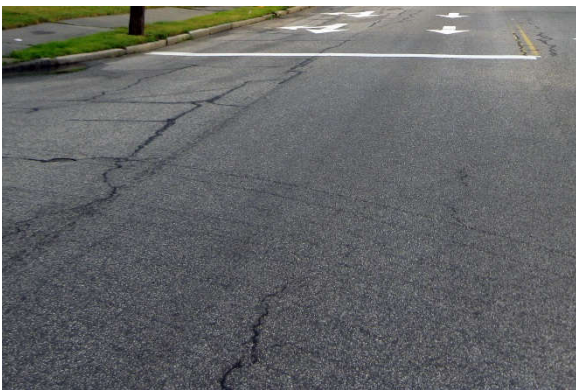
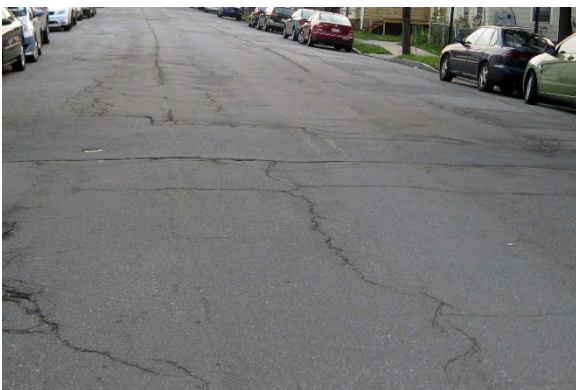
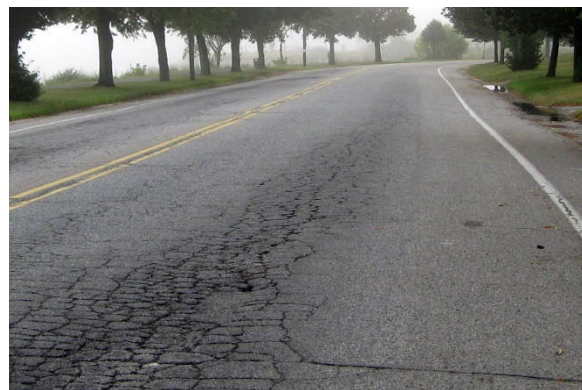
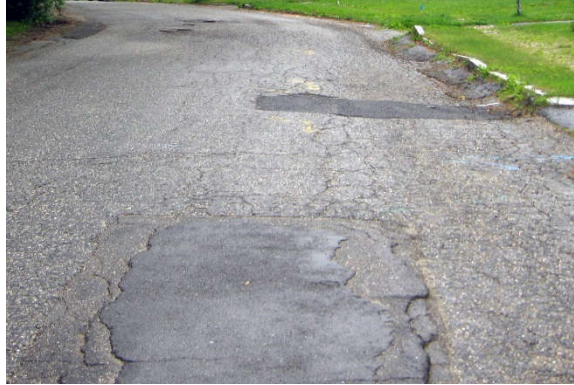
Figure 5 below depicts representative examples of the various PCI pavement conditions. Please note that none of these images were taken in Gray. They're intent is to show approximately what each condition category may look like.

Figure 5 - Pavement Condition Examples. Note: The photographs in Figure 5 above represent examples of pavement conditions and were not necessarily taken in Gray.

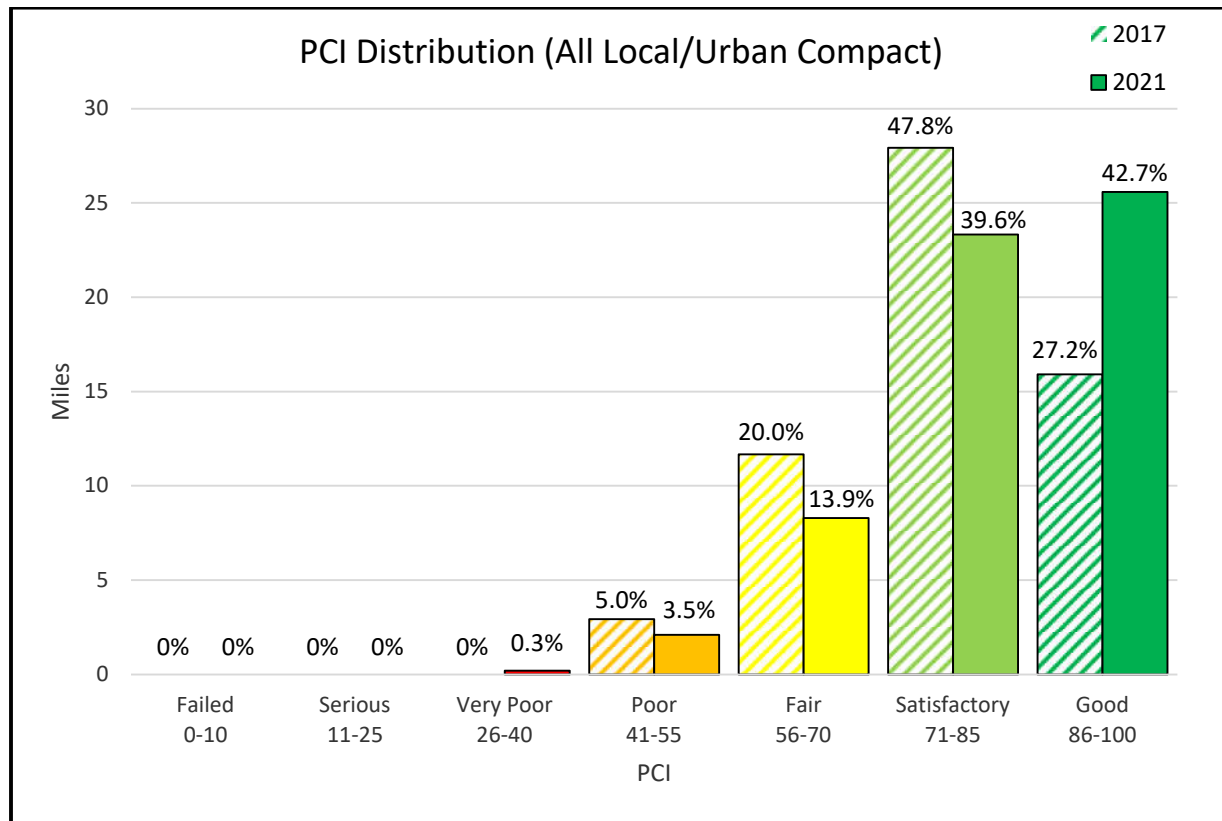
Approximately 96.2% (57.2 out of 59.5 miles) of all local/urban compact roads have a PCI of 56 (Fair) or better. Approximately 78.9% (12 out of 15.2 miles) of all state roads have a PCI of 56 (Fair) or better. Figures 6 and 7 below show the PCI rating versus roadway miles for local/urban compact and state roads respectively. The percentages above each bar represent the percentage of road miles in those conditions.

Figure 6 – PCI Distribution vs. Miles for 2021 (local/urban compact roads only)

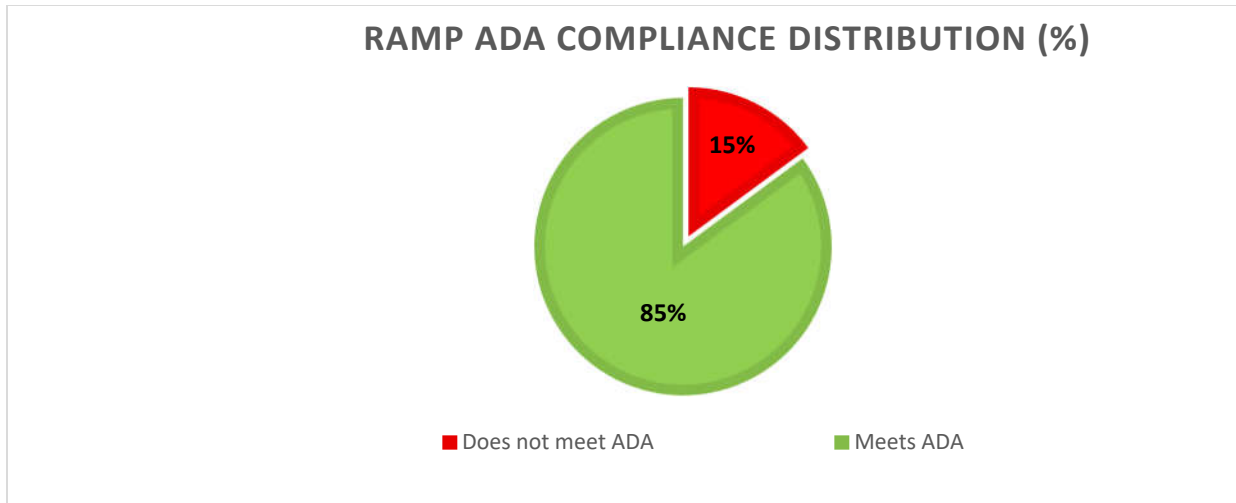
In addition to sidewalks, a separate inventory of the existing sidewalk ramps was documented and included in Appendix C. Sidewalk ramps are typically located at intersecting streets where the sidewalk transitions to a roadway crossing (i.e. crosswalk). In some cases, crossings are not located at intersecting streets but at high volume locations that provide pedestrian connectivity to either side of the road. These locations are often called “mid-block crossings”. As noted above, sidewalks (and ramps) associated with public facilities (Town Office, Library, etc.) were not included in the survey. The Town has a total of 47 sidewalk ramps along public roadways. Approximately **40** ramps (85%) were noted as meeting ADA standards.

Figure 18 – Percentage of Sidewalks in each Condition

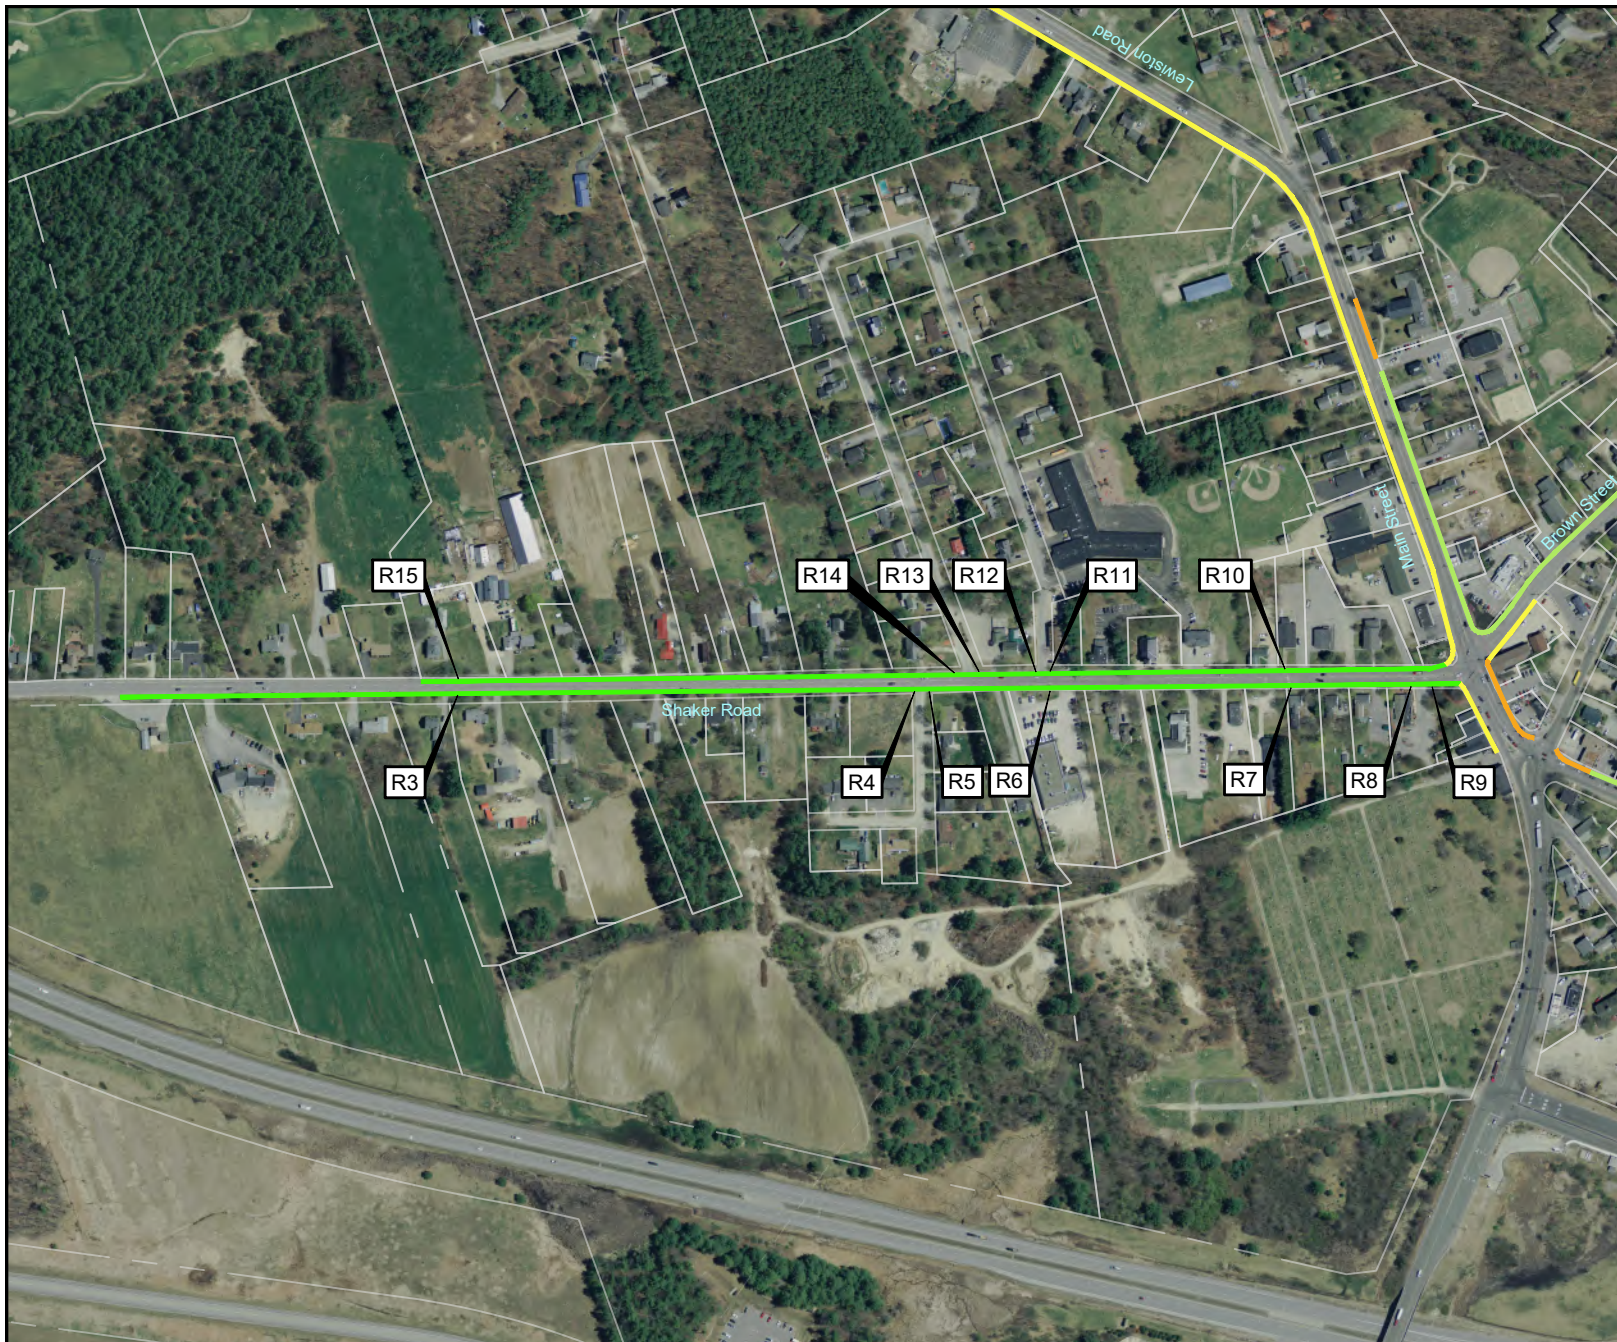
Figure No.
1

Drawing Name: **Shaker Road**
 Project: **2021 Sidewalk Condition Survey**
 Gray, Maine

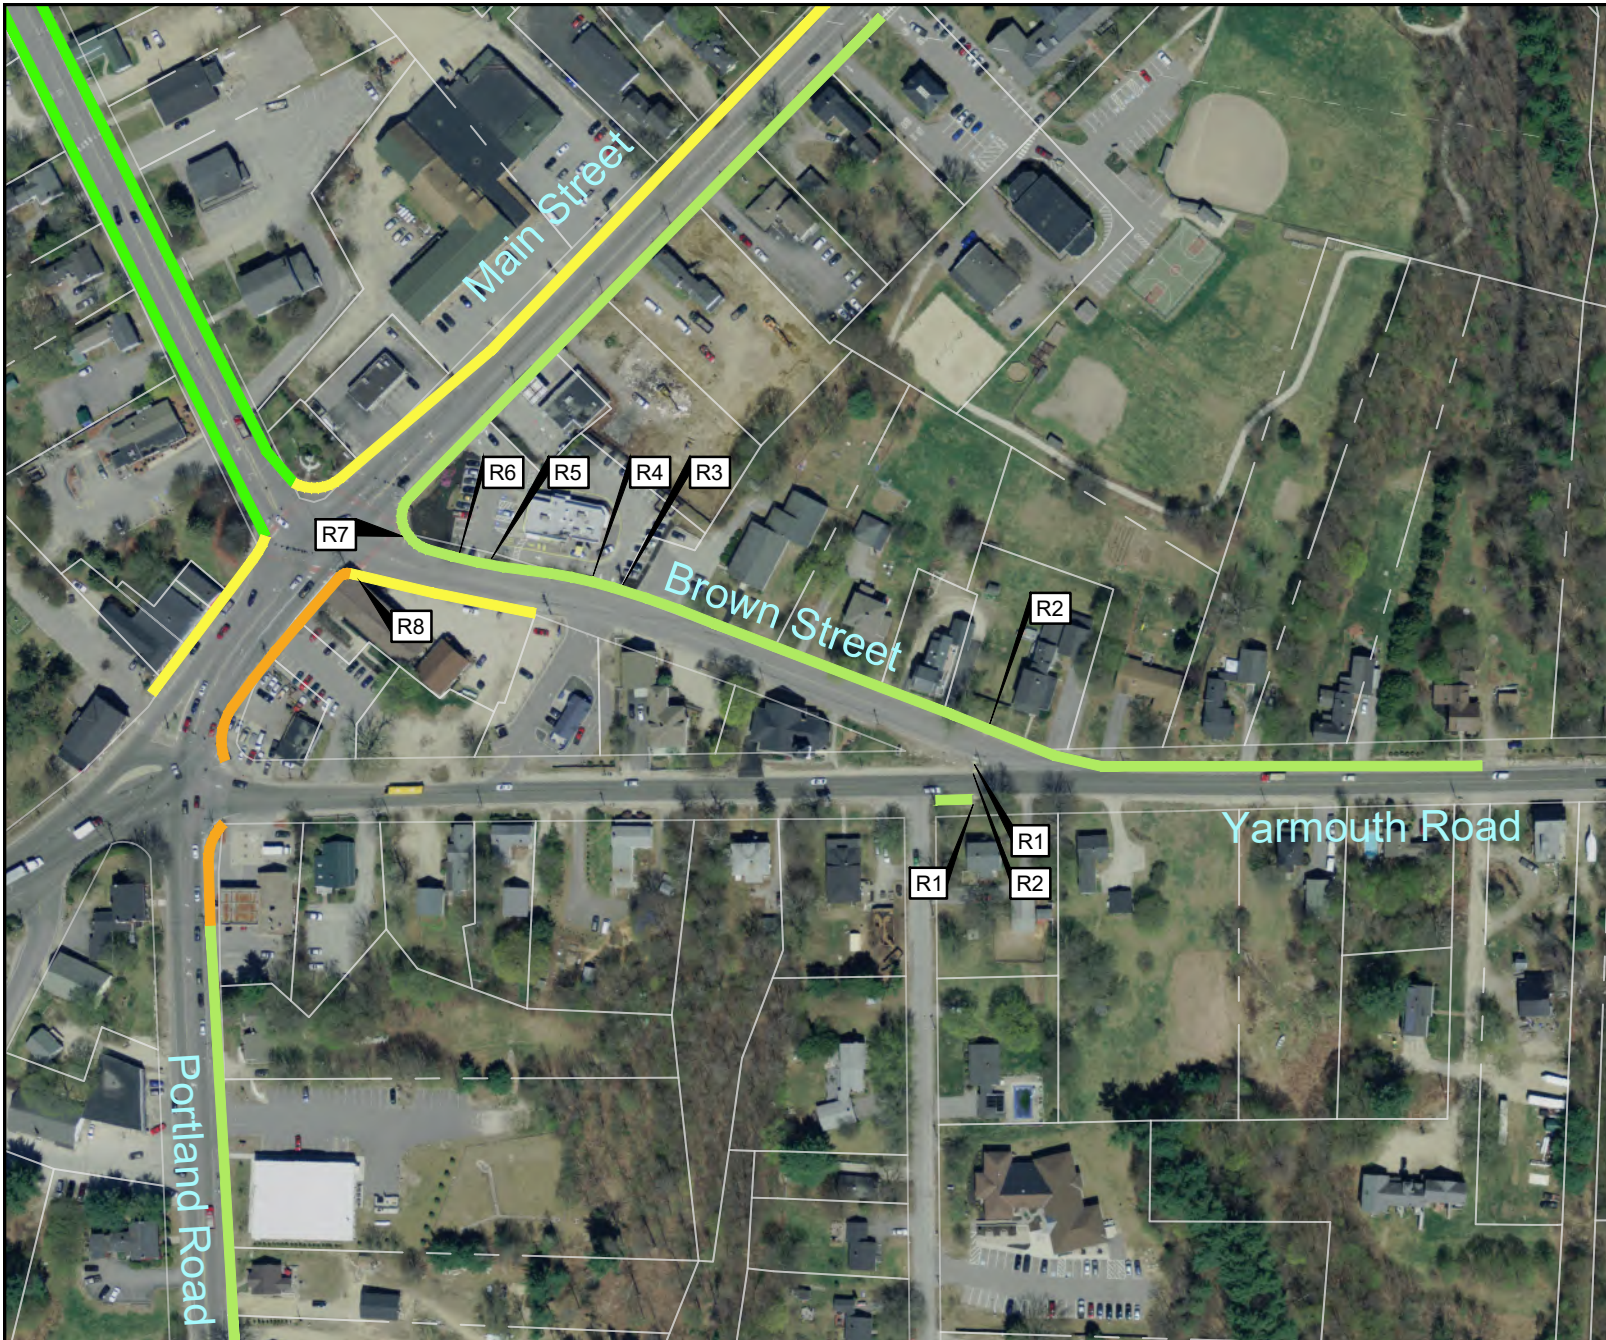
Figure No.
2

Drawing Name: **Brown Street & Yarmouth Road**
 Project: **2021 Sidewalk Condition Survey**
 Gray, Maine

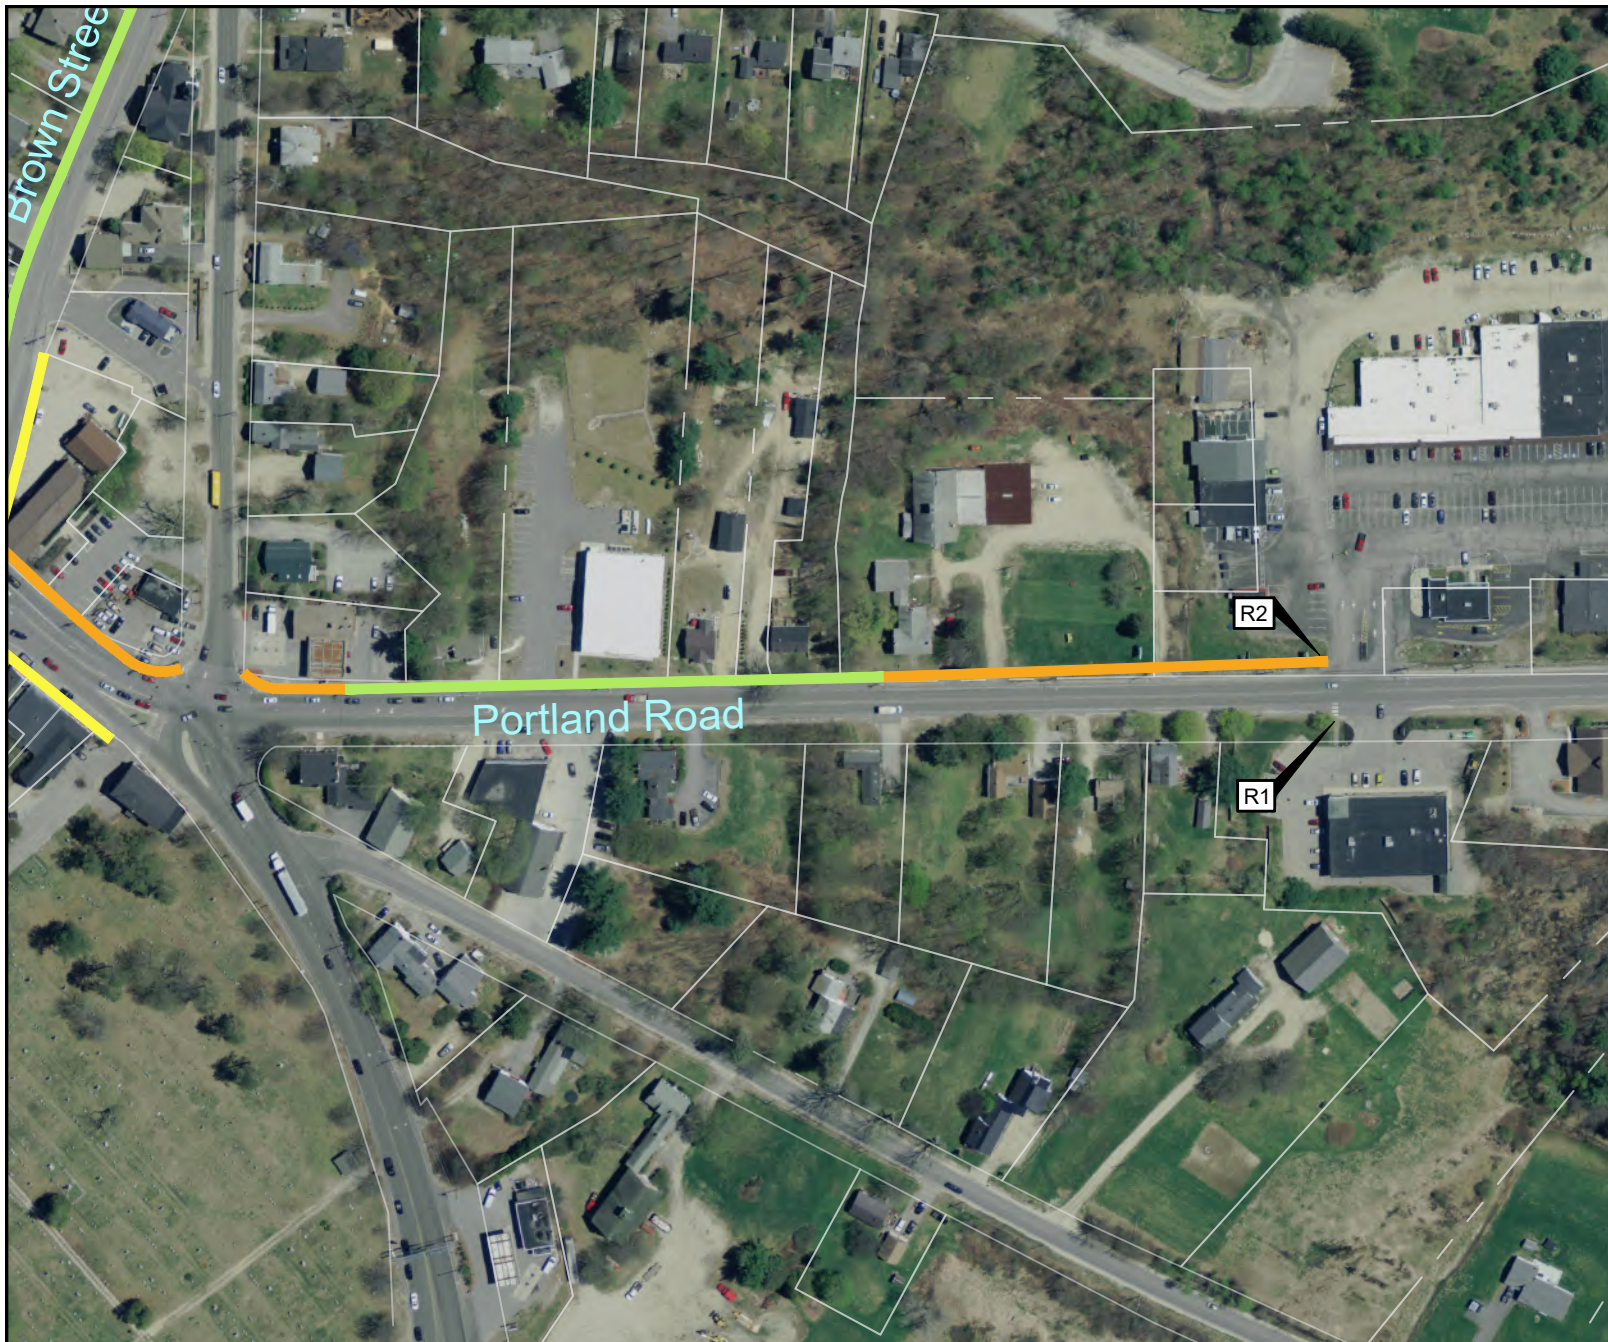
Figure No.
5

Drawing Name: **Portland Road**
 Project: **2021 Sidewalk Condition Survey**
 Gray, Maine
